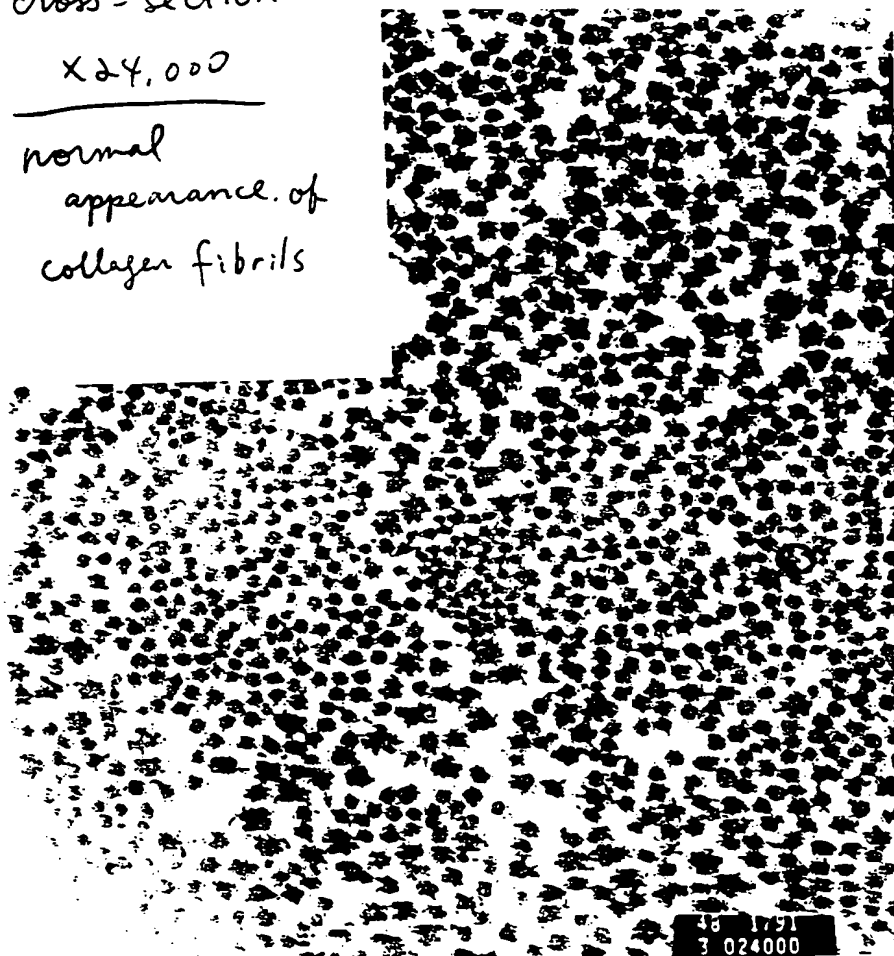
Figure 11

1.(a) # 1791

Untreated area  
cross-section

X 24,000

normal  
appearance of  
collagen fibrils

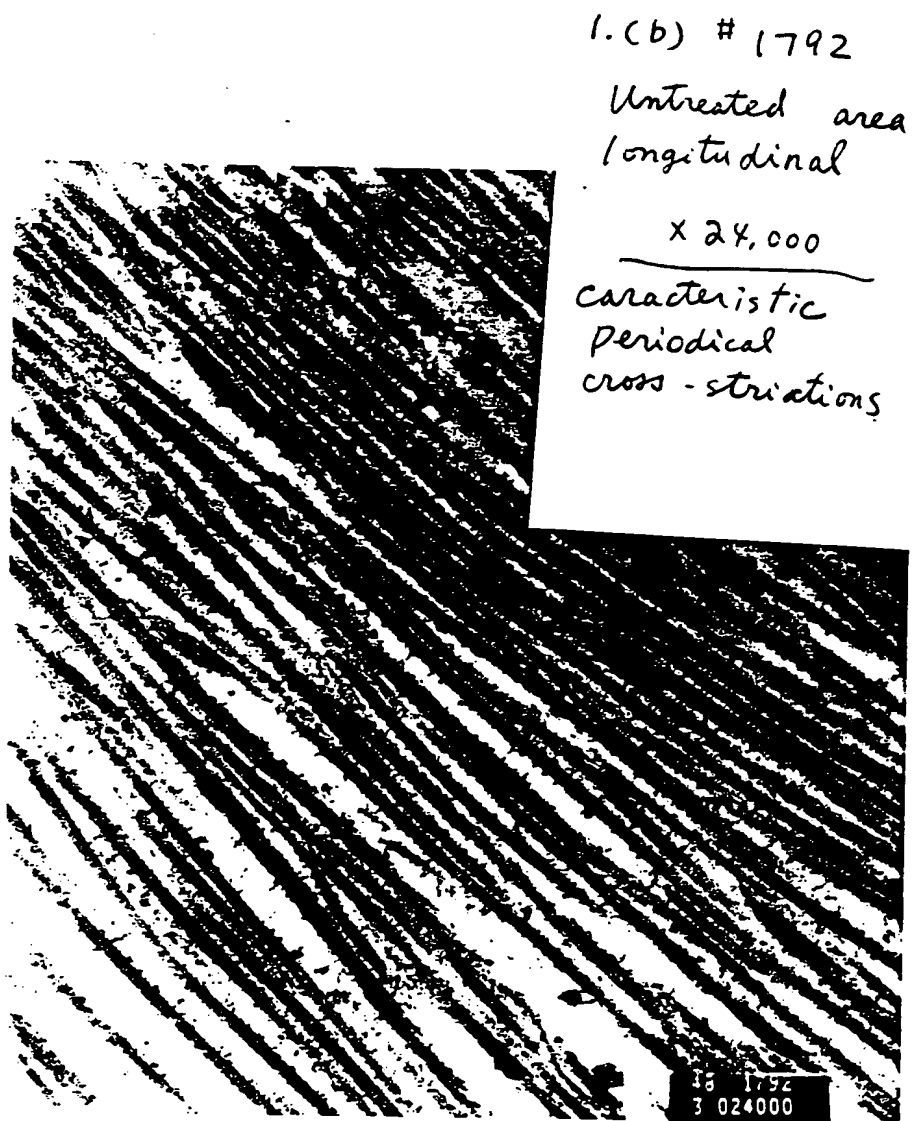
Figure 12

2.(a) # 1779

Treated,  
surface ~ 2 mm  
deep.  
cross-section

X 24,000

increased diameter  
with loss of distinct  
edges.  
visible fine structures.
